Manhole Inspection Summary

Manhole # S51W1_005MH

Insp Date: **4/16/09 9:41 AM**

Location Address: **1900 Chesapeake Ave.**

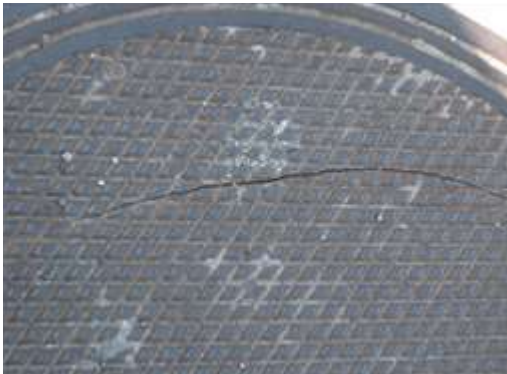
Defect 2

Condition: **Cracked**

Cracked Cover

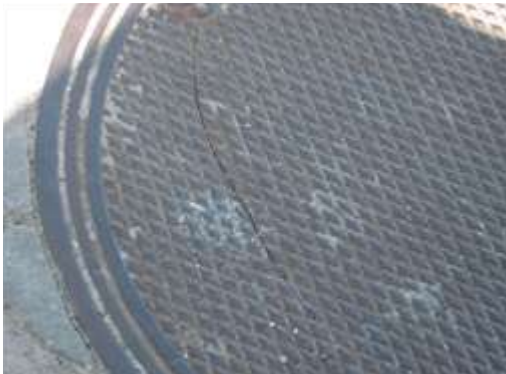
Defect 1

Cracked Cover

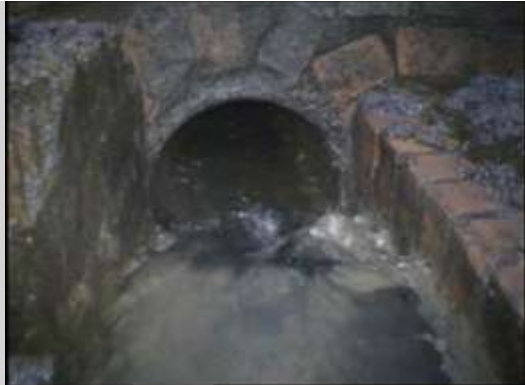
12 O'Clock Outflow

10 in. Circular Gravity Sewer
Pipe Out @ 12 O'Clock

Pipe Height: **12** (in.) Rod and Bar (Angled)
Pipe Material: **Unknown** ☐ Pipe Lined
Invert Depth: **12.40** (ft.) Flow Characteristics: **Fast**
Deposits: ☒ None ☐ Mud ☐ Sludge ☐ **Debris** ☐ Grease
Silt Depth: (in.) Deposits Extent:
Infiltration: **None** Pipe Seal Cond: **Sound**

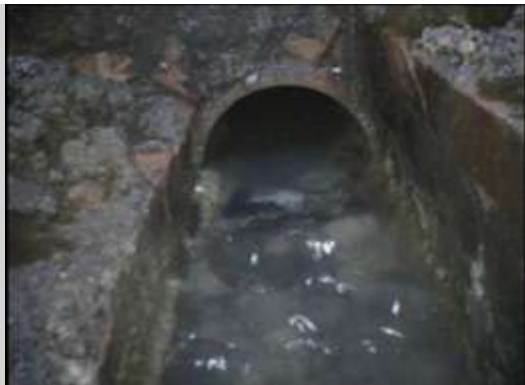
6 O'Clock Inflow

10 in. Circular Gravity Sewer
Pipe In @ 6 O'Clock

Pipe Height: **10.8** (in.) Rod and Bar (Angled)
Pipe Material: **Unknown** ☐ Pipe Lined
Invert Depth: **12.30** (ft.) Flow Characteristics: **Fast**
Deposits: ☒ None ☐ Mud ☐ Sludge ☐ **Debris** ☐ Grease
Silt Depth: (in.) Deposits Extent:
Infiltration: **None** Pipe Seal Cond: **Sound**

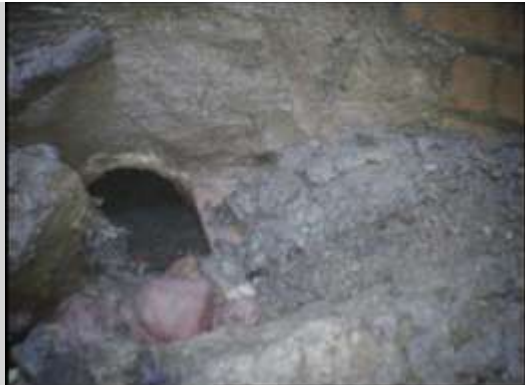
8 O'Clock Inflow

4 in. Circular Gravity Sewer

Pipe In @ 8 O'Clock

Deposits: ☐ None ☐ Mud ☐ Sludge ☒ **Debris** ☐ Grease

Silt Depth: **3** (in.) Deposits Extent: **Heavy**
